IMPACT RESISTANCE OF SPAR-SHELL COMPOSITE FAN BLADES

J. GRAFF, L. STOLTZE AND E. M. VARHOLAK

HAMILTON STANDARD DIVISION UNITED AIRCRAFT WINDSOR LOCKS, CONNECTICUT 06096

CONTRACT NAS3-16778

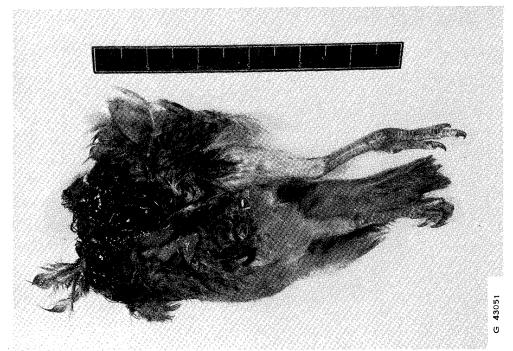
B) POST TEST CONDITION WEIGHT 222 GM (0, 50 LB)

To confirm actual slice size, the birds were weighed before and after the test. Figure 9 shows the slice surface of the three birds impacted.

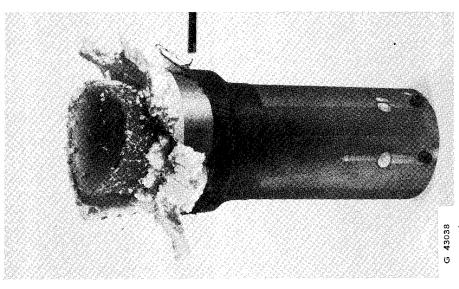
B) SIMULATED BIRD – 909 GM (2,0 LB)

On site tap test was performed before FOD testing to verify the structural integrity of the blade. One blade test, the 909 gram (2.0 pound) gelatin simulated bird test resulted in loss of the shell and the leading edge sheath, approximately 20% of the total blade weight.

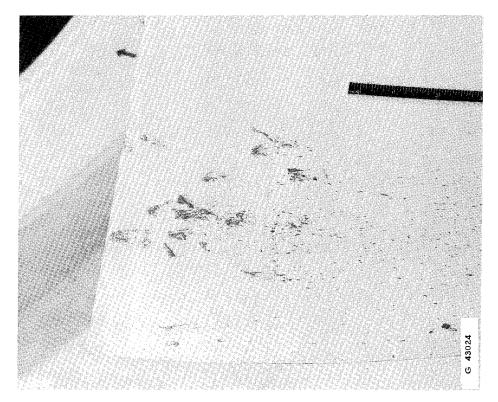
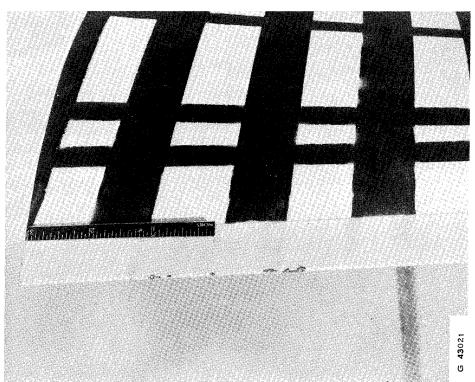
FIGURE 10. STONE EROSION - BLADE B-1

- 1. Stone test The paint was blemished at the impingement sites. Indentions on the immediate leading edge extended to a depth of 0.005 cm (0.002 inch) Figure 10 shows this blade after the stone impact test run.
- 2. Rivet test Paint was removed at the impact sites. Figure 11 shows this blade after the rivet test run.
- 3. Steel nut test The strike was on the sheath on the face side of the blade. The depth of the indentation in the sheath was 0.102 cm (0.040 inch). The width was 1.52 cm (0.6 inch). Figure 12A shows the blade after nut impact.
- 4. Bolt test The bolt impacted directly on the leading edge. The impact produced an indentation 0.19 cm (0.060 inch) deep and 0.508 cm (0.200 inch) wide. The leading edge was also slightly bent toward the face side, approximately 0.152 cm (0.060 inch). Figure 12B shows the blade after the bolt impact.

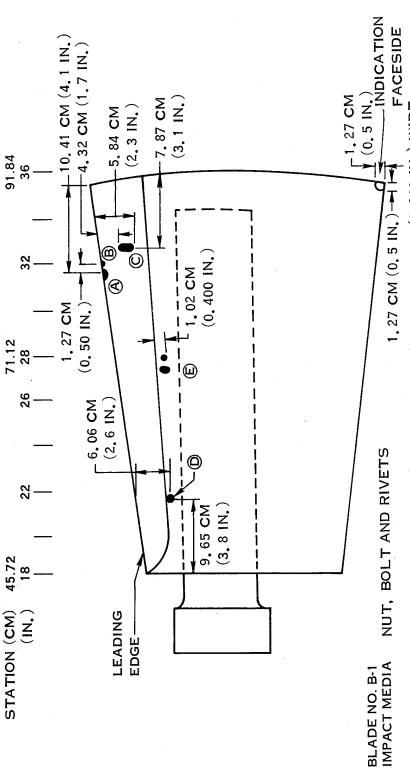
FIGURE 13. SMALL MEDIA IMPACT LOCATIONS - BLADE B-1

The blade frequencies are presented in Table V. No significant change was noted on Blade B1 resulting from the tests. Figure 13 summarizes the location and effect of the impacts on the blade.

LEAD EDGE - BOLT STRIKE 1,91 CM (0,075 IN.) DENT 0,51 CM (0,200 IN.) WIDE **3**

CURLED TOWARD FACE APPROXIMATELY 0, 15 CM (0, 060 IN.)

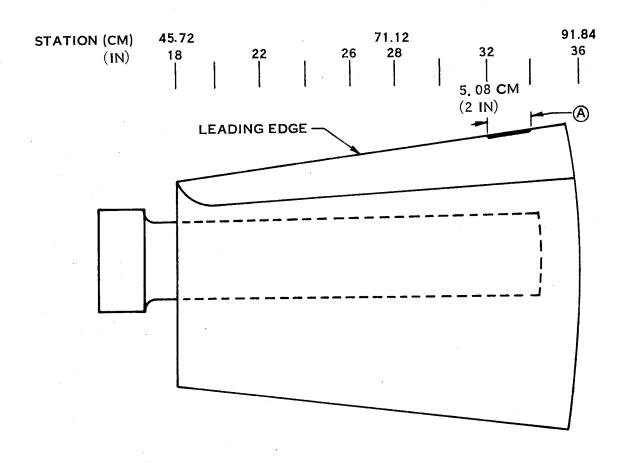
This blade was impacted by a 5.08 cm (2.0 inch) diameter iceball in each of two tests. Specific characteristics of this media are shown in Table III. The blade struck about 25% of the first iceball and 100% of the second. There was no internal structural damage. A drop in the second flatwise static frequency of 2.8% coupled with minor change in the first flatwise mode and the first torsion mode were not considered significant since the displacement of the leading edge is expected to modify the blade resonance slightly in this direction. Frequency data is presented in Table V.

IMPACT MEDIA 5. 08 CM (2 IN) ICE BALLS-STRUCK WITH 2 BALLS (APPROX. 56 GM EACH)

(A) LEAD EDGE OVER 5. 08 CM (2 IN) LENGTH BENT SLIGHTLY TOWARD CAMBER 0. 10 CM (0. 040 IN) AT MAX DEFLECTION

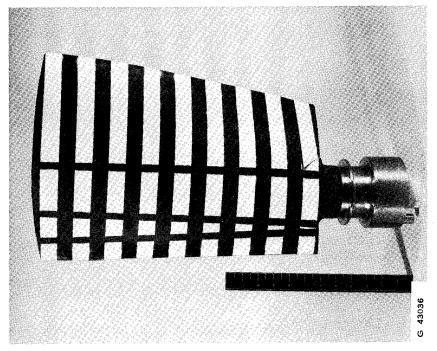
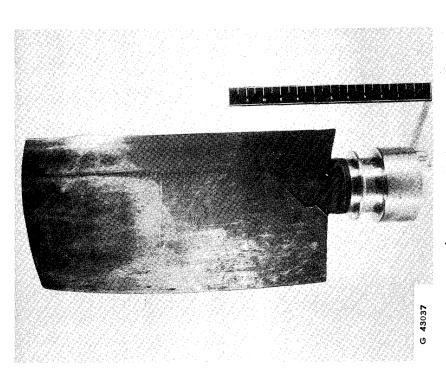
This blade was impacted by a 454 gram (1 pound) simulated gelatin bird. The slice removed by the blade as the result of the impact was 249 grams (0.55 pound). Visual examination of the blade after impact revealed sheath deformation in the impact region and shell fractures in the inboard area of the blade on both sides. Figures 15 and 16 show this damage. Tap and other visual indications are presented in Figure 17. Some reduction in frequencies were observed as the result of impact. These are shown in Table V. A drop of 5% in a frequency was considered evidence of structural damage to the blade. As indicated in the table, the first torsional frequency was especially effected, dropping 16.1%.

SIMULATED BIRD STRIKE TEST BLADE B-3 - POST TEST CONDITION BIRD WEIGHT 454 GM (1, 0 LB); 255 GM (9 OZ) SLICE SIZE FIGURE 15.

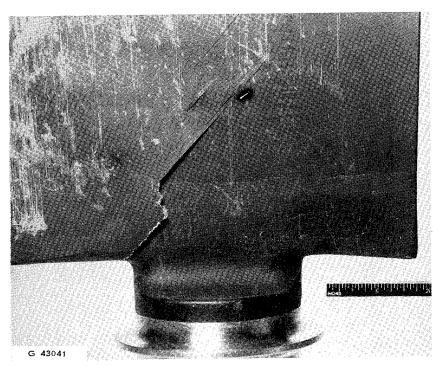
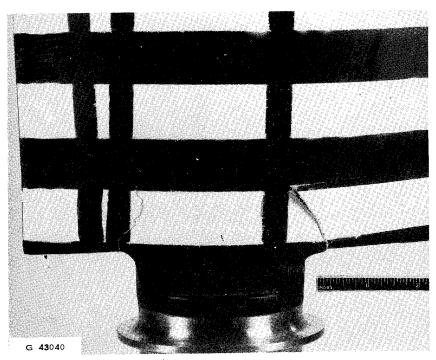
FIGURE 16. 454 GM (1.0 LB) SIMULATED BIRD TEST — BLADE B—3
POST TEST CONDITION — IN BOARD END; 255 GM (9 OZ)
SLICE SIZE

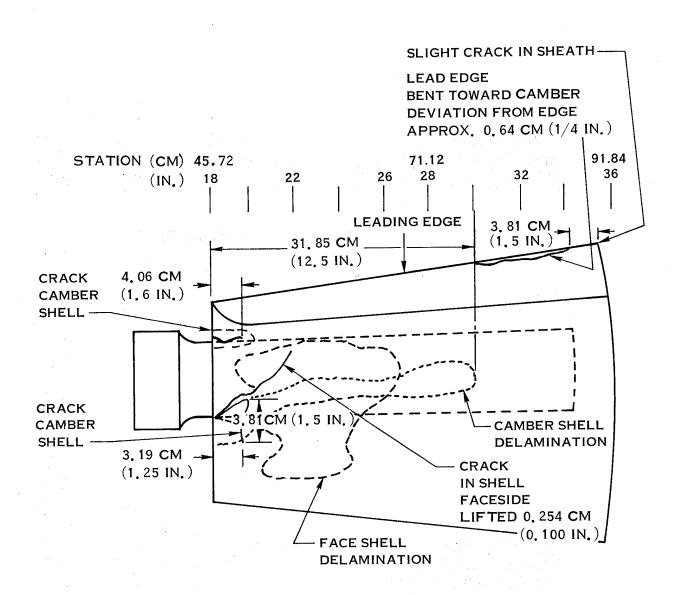
FIGURE 17. POST TEST CONDITION - BLADE B-3

IMPACT MEDIA 454 GM (1 LB) SIMULATED BIRD - 56% HIT

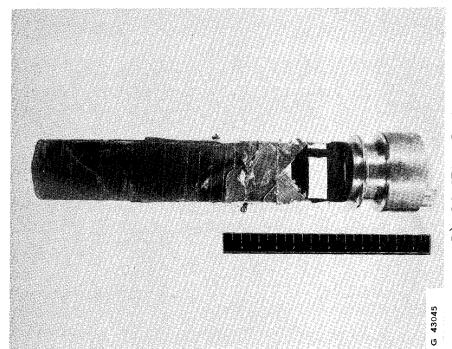
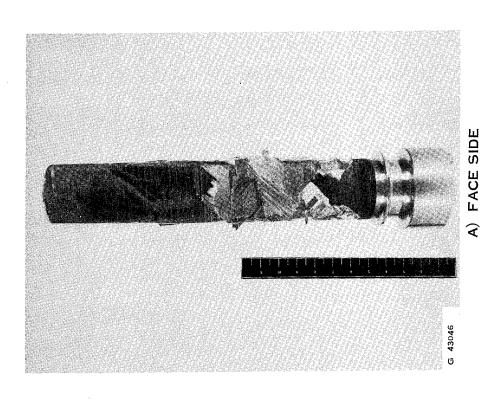
This blade was impacted by a 909 gram (2 pound) simulated gelatin bird. The slice removed by the blade was 319 grams (0.7 pound). As a result of impact, the shell, sheath and foam fill separated from the blade, leaving the titanium spar. The loss represented only about 21% of the total blade weight. Figure 18 shows the remaining spar. In the spar area, the fracture mode, as shown in Figure 18 was by interlaminar shear in the composite shell, since material from the inner plies of the

SIMULATED BIRD STRIKE BLADE B-5 - POST TEST CONDITION BIRD WEIGHT 909 GM (2 LB); 316 GM (11 OZ) SLICE SIZE FIGURE 18.

shell remained securely bonded to the spar. No failure of the structural adhesive was observed. In addition, no spar damage was detected by Zyglo inspection of the spar and retention.

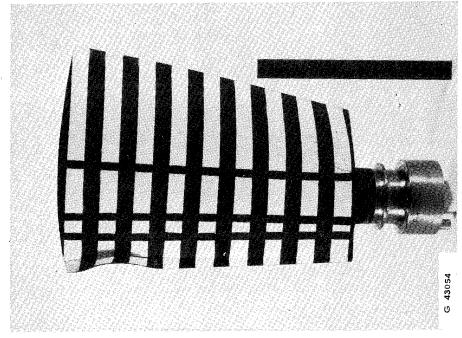
This blade was impacted by a 499 gram (1.1 pound) chukar partridge. The slice removed by the bird as the result of the impact was 272 grams (0.6 pound). Visual examination of the blade after impact revealed sheath deformation in the area of impact and fractures in the inboard area of the blade similar to those present on B-3. Figures 19 and 20 show these areas. Tap and visual indications are presented in Figure 21. As indicated in Table V the drop in frequency in the first torsional mode was 10% indicating blade structural damage. Eyelash airfoil plots of two stations are presented in Figure 22. They represent the airfoil at the 50.8 cm (20 inch) and 81.3 cm (32 inch) airfoil stations, the latter being the impact station.

FIGURE 19. REAL BIRD STRIKE — BLADE B—4
POST TEST CONDITION
BIRD WEIGHT 499 GM (1.1 LB)
SLICE SIZE 277 GM (9,7 OZ)

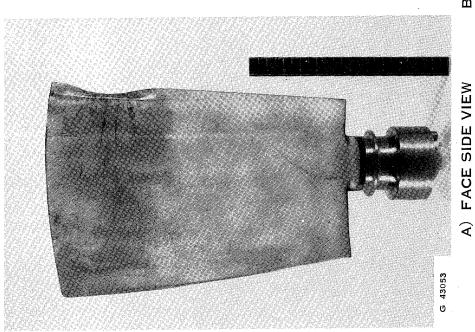
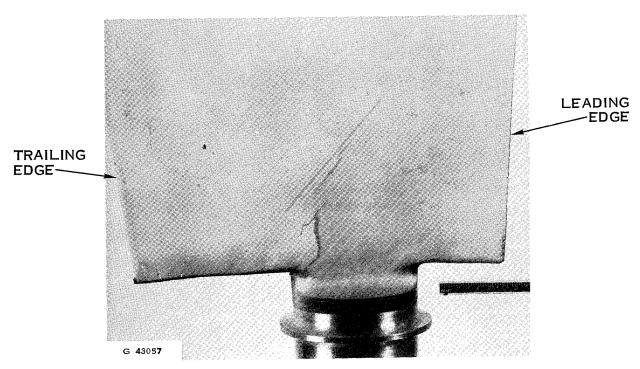
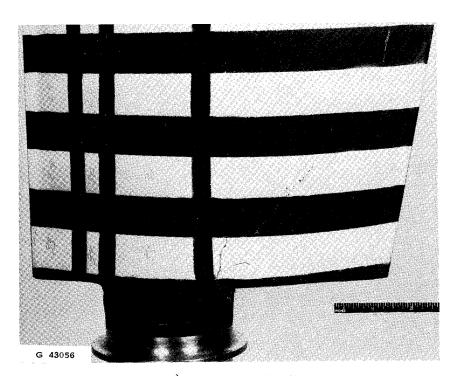
FIGURE 20. REAL BIRD STRIKE TEST BLADE B-4
INBOARD AREA - POST TEST CONDITION
BIRD WEIGHT 499 GM (1, 1 LB)
SLICE SIZE 277 GM (9, 7 OZ)

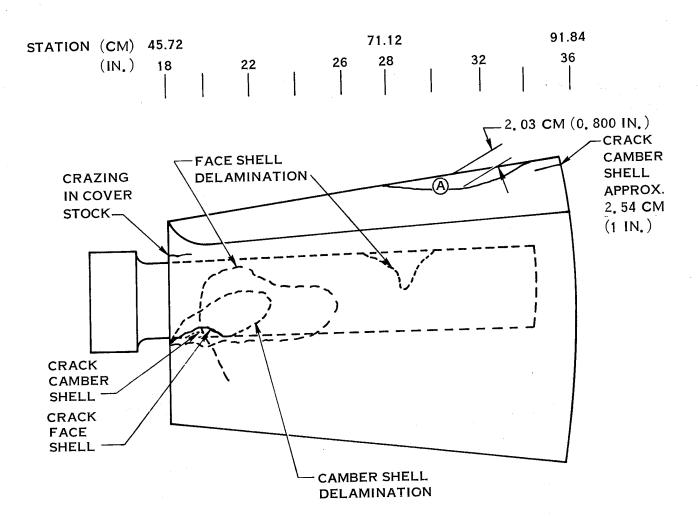
IMPACT MEDIA: CHUKAR PARTRIDGE - 499 GM (1, 1 LB) 55% SLICE SIZE

(A) LEAD EDGE OF SHEATH CURLED BACK 2, 03 CM (0, 800 IN.)

1.57 RAD (90°) TO CHORD ON CAMBER SIDE.

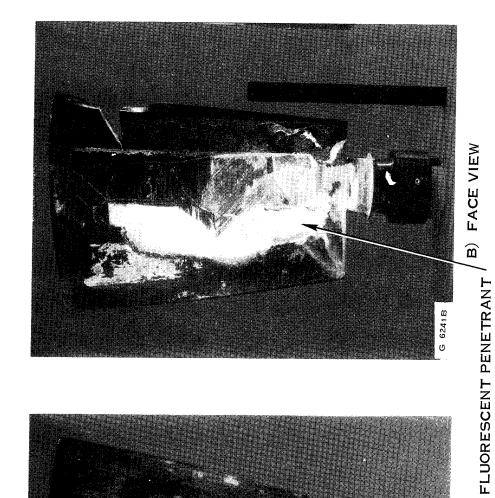
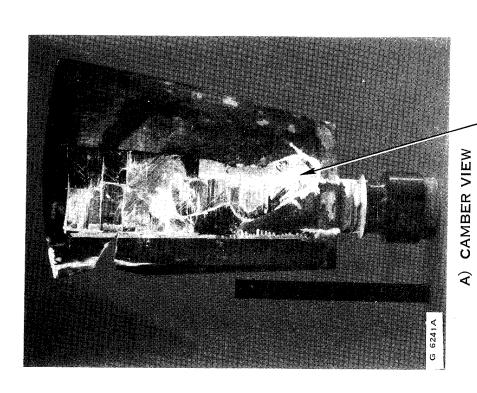
FIGURE 23. DESTRUCTIVE EXAMINATION BLADE B-4

The destructive examination of B-4 was conducted by the dye penetrant method previously described. The examination essentially confirmed the damage evidenced by the NDE. Slightly more interlaminar fracture was discovered on the camber side of the blade. This fracture extended from the spar tip to the leading edge impact area. Also, the face side exhibited shell to foam delamination aft of the spar. The increased thickness of the shell in these areas is the probable cause for the NDE insensitivity. Figure 23 outlines the areas of damage destructively determined. A section of the leading edge sheath was removed to determine the extent of impact damage to it. A photomicrograph of the sheath section is presented in Figure 24. Gross bending of the sheath is evident in the section in the blade aft of the solid portion of the leading edge. This resulted from a gap left inadvertently between the leading edge solid section (insert) and the composite shell during sheath bonding. There is also evidence of impact induced debonding in the braze joint between the leading edge insert and the face side sheath flank.

CHORDWISE SECTION AT 81.3 CM (32.00 IN.) STATION
